Location-1 current scenario at Thurakapally Junction:
Latitude: 17.672381°
Longitude: 78.593087°

GK Consulting Engineers – Company Profile

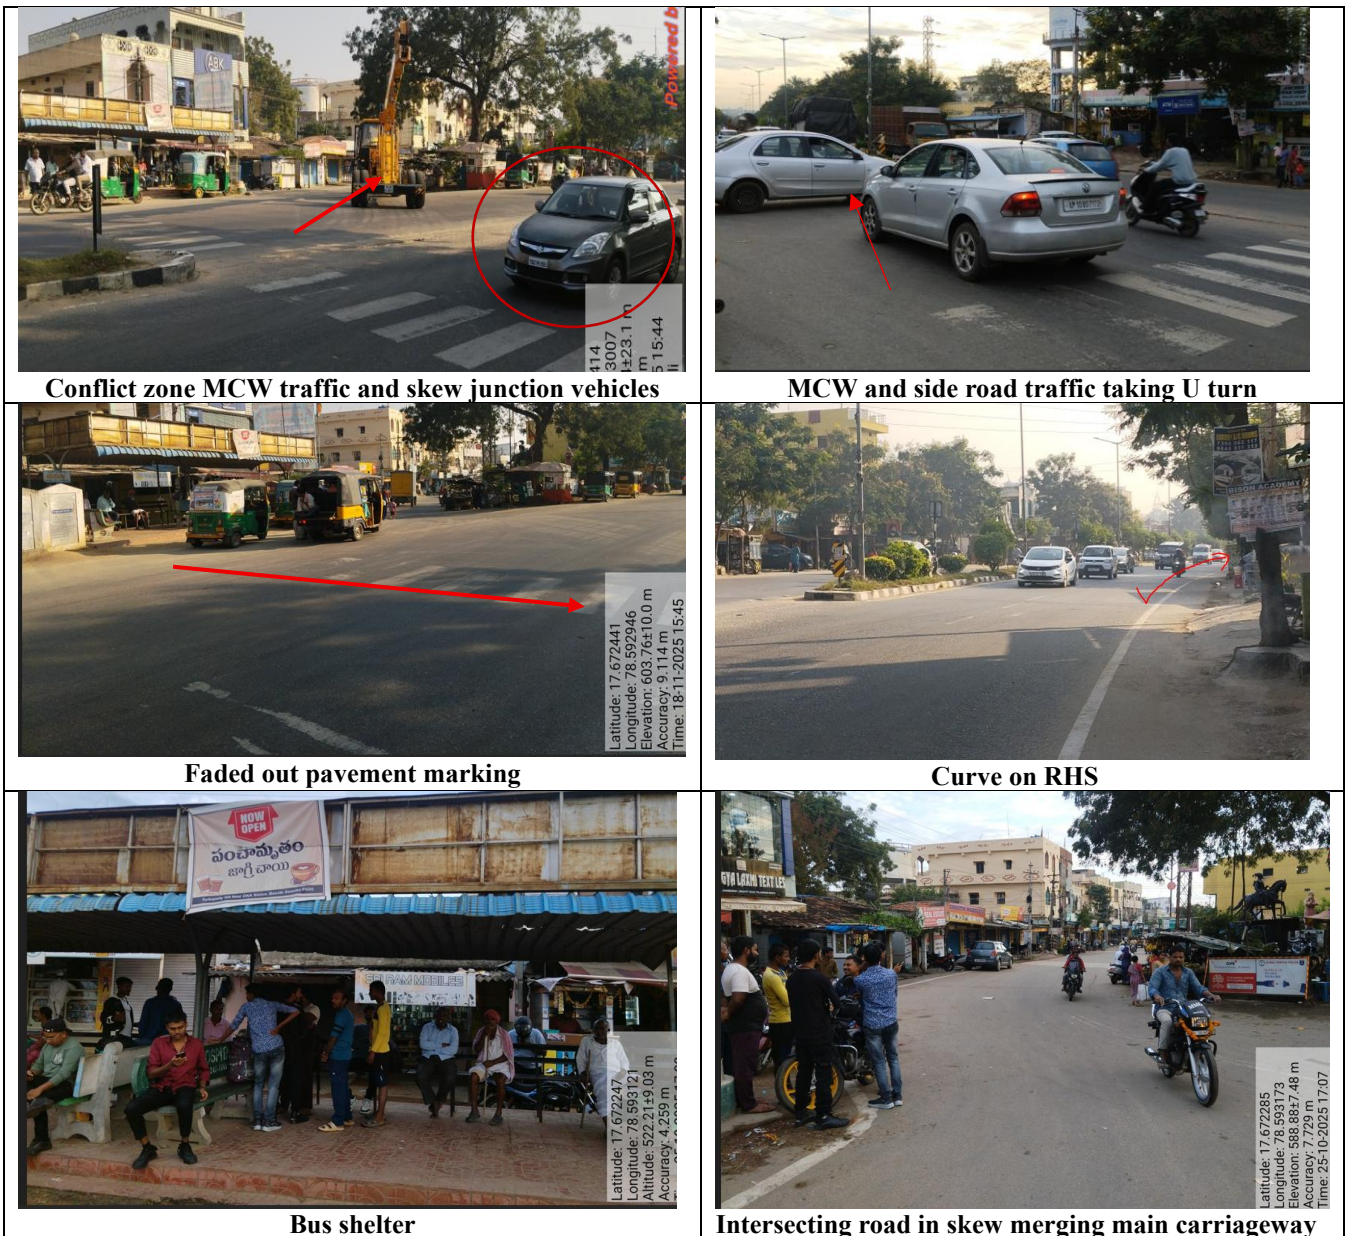
Existing photographs at this location

At present, the Thurakapally Junction is located between a left-hand horizontal curve on the approach side and a right-hand horizontal curve on the departure side of the main carriageway, with a skewed intersecting road, an existing median opening, and a bus shelter situated within a short junction influence area. This substandard geometric configuration results in inadequate sight distance and multiple vehicular conflict points between main carriageway and intersecting road traffic, further taking U-turn movements at the median opening. The bus shelter induces bus stoppages and pedestrian congregation close to the carriageway, leading to congestion, visibility obstruction, and driver confusion issues. The horizontal curves on both approaches restrict advance visibility, especially during night-time, causing sudden braking and unsafe movements, which increase the likelihood of rear-end and side-swipe collisions. Because of all these issues together, the Thurakapally Junction has become an accident-prone area and needs immediate safety improvements.

Conflict zone MCW traffic and skew junction vehicles
MCW and side road traffic taking U turn
Faded out pavement marking
Curve on RHS
Bus shelter
Intersecting road in skew merging main carriageway
Major Observations

1. Pavement markings at this location are faded and not clearly visible.
2. Several road studs are damaged and not functioning properly.
3. Adequate highway lighting is available at this location.
4. The existing transverse bar markings are faded and not clearly effective.

1. Provide three sets of **Transverse Bar Markings (TBM)** of 5 mm thickness on both approaches to the median opening at distances of 50 m, 80 m, and 120 m, along with road studs, to achieve effective speed reduction.

2. Install “**Accident-Prone Area**” warning signboards on both sides of the main carriageway and the intersecting road to alert drivers and improve safety awareness.

3. Provide **solar blinkers** on both approaches to enhance night-time visibility of the junction and conflict areas.
4. Provide **pavement markings** such as pedestrian crossing markings, edge lines, and centre lines as per IRC:35-2015, supplemented with road studs for improved delineation.

5. Provide hazard pavement markings at the Junction location as per IRC:35-2015 to warn drivers about the accident-prone zone.
6. Provide three sets of **Transverse Bar Markings (TBM)** of 5 mm thickness on the intersecting road at distances of 50 m, 80 m, and 120 m in advance of the merging point with the main carriageway, along with road studs, to control approach speeds.

1. The junction shall be improved by converting it into a properly designed signalised intersection to regulate traffic movements and enhance overall safety.

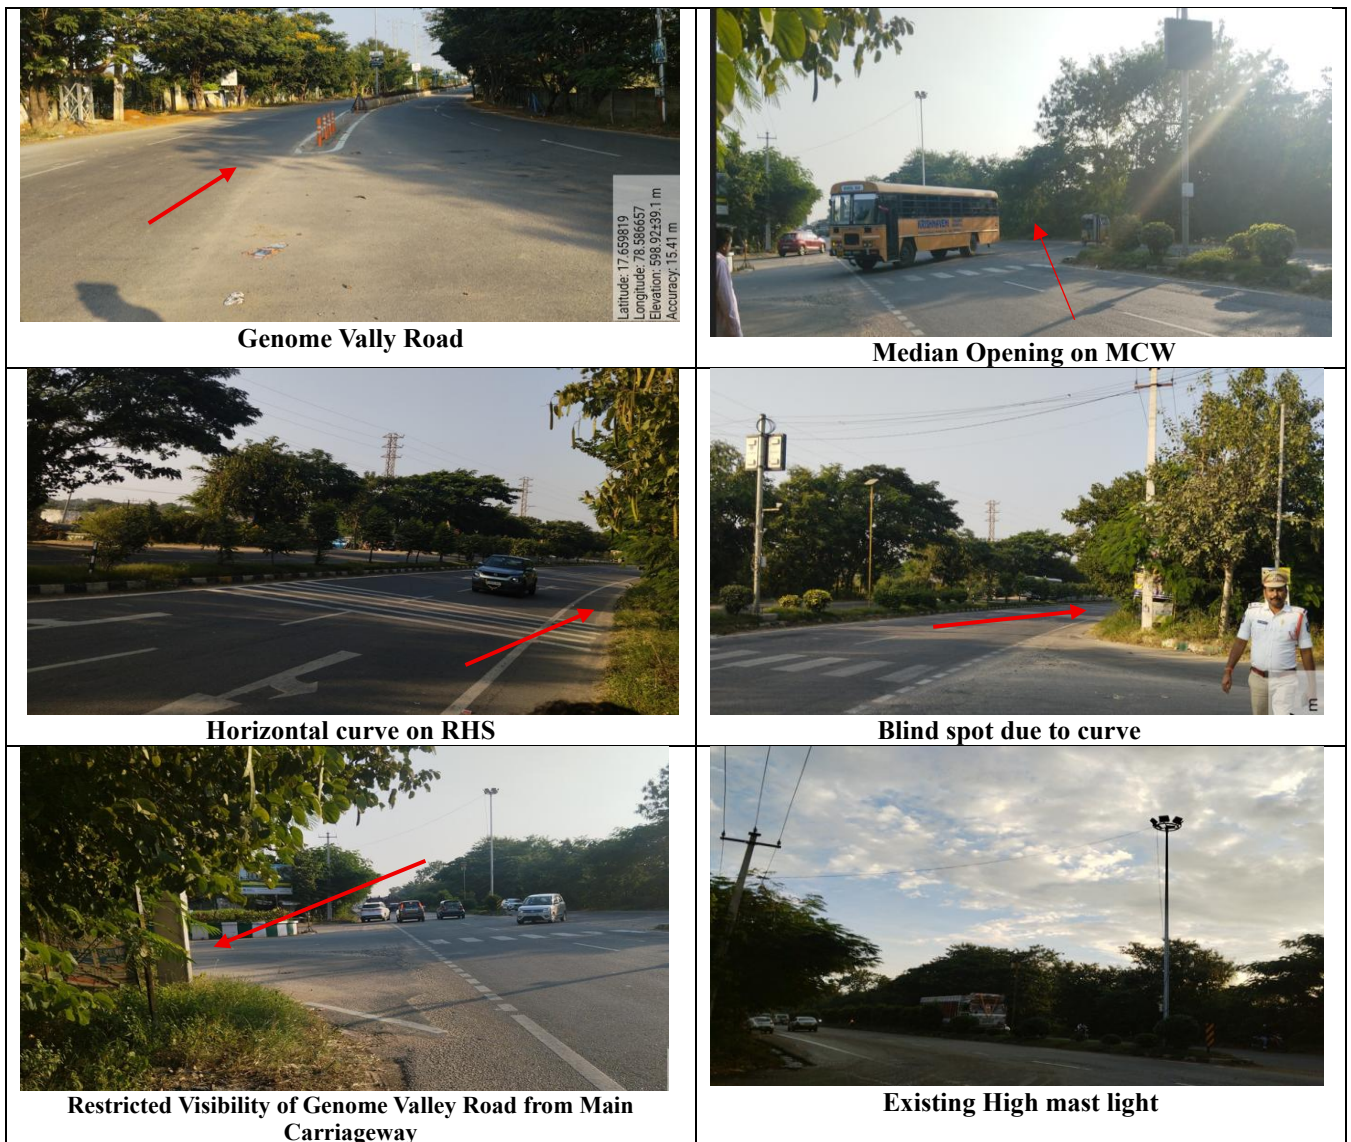
Existing photographs at this location

At present, an intersecting road known as **Genome Valley Road** connects to the **right-hand side (RHS) of the main carriageway (MCW)** through an existing median opening. A horizontal curve is located on the RHS approach of the MCW upstream of the Genome Valley junction, which significantly restricts advance visibility and creates a **blind spot** for through traffic. As a result, approaching MCW vehicles are unable to clearly perceive the intersecting road and merging traffic in time. A high volume of mixed traffic, ranging from heavy vehicles to small vehicles, enters the MCW from Genome Valley Road and frequently executes **U-turn movements at the median opening** to travel towards Karimnagar, while through traffic continues towards Hyderabad. These conflicting traffic movements, combined with inadequate road safety measures and restricted sight distance due to the horizontal curve, lead to frequent vehicle conflicts between MCW and intersecting road traffic, predominantly resulting in **side-swipe collisions**. Due to poor visibility, uncontrolled U-turn movements, and heavy interaction between vehicles, the Genome Valley junction has become an **accident-prone area** and needs immediate safety improvements.

1. Pavement markings at the junction are worn out and lack adequate visibility.
2. Several road studs are damaged and are not effectively delineating the carriageway.
3. Existing transverse bar markings are faded and have lost their functional effectiveness.
4. Only one high-mast light is available at the junction, which is inadequate to ensure proper illumination of the conflict area.
5. Solar blinkers installed on the BHS on MCW are provided and are presently functional.
6. Junction improvement signboards such as **STOP**, **speed limit**, and **junction ahead** warning signs are not provided on the Genome Valley Road.

1. Provide three sets of **Transverse Bar Markings (TBM)** of 5 mm thickness on both approaches to the median opening at distances of 50 m, 80 m, and 120 m, along with road studs, to achieve effective speed reduction.

2. Install “**Accident-Prone Area**” warning signboards on both sides of the main carriageway and the intersecting road to alert drivers and improve safety awareness.

3. Provide **pavement markings** such as pedestrian crossing markings, edge lines, and centre lines as per IRC:35-2015, supplemented with road studs for improved delineation.

4. Provide hazard pavement markings at the Junction location as per IRC:35-2015 to warn drivers about the accident-prone zone.
5. Provide three sets of **Transverse Bar Markings (TBM)** of 5 mm thickness on the intersecting road at distances of 50 m, 80 m, and 120 m in advance of the merging point with the main carriageway, along with road studs, to control approach speeds.

6. Provide appropriate junction control and warning signboards on Genome Valley Road, such as **STOP**, **speed limit**, and **junction ahead** signs, as per IRC:67-2022, to regulate vehicle movements, improve driver awareness, and enhance overall junction safety.

7. Provide green-coloured road studs at the crossable lane markings at the Genome Valley Road and main carriageway merging location to improve delineation and driver guidance.

8. Provide highway lighting for a length of 250 m on both sides of the median opening, i.e., towards Hyderabad and towards Karimnagar, to improve visibility and safety.

1. Remove or trim roadside vegetation, trees, posters, and any obstructions within the **intersection sight distance (ISD)** envelope to restore visibility of the intersecting road.
2. **Advance Warning Signage on MCW**
Install “Junction Ahead” and “speed limit sign board” warning signboards on MCW as per IRC:67-2022, to alert drivers of the upcoming conflict point.

1. **Geometric Junction Improvement:** Reconfigure the intersection geometry by improving the approach alignment or channelizing movements to reduce direct conflicts between MCW and intersecting road traffic.
2. **Access Control at Median Opening:** Restrict or relocate the existing median opening away from the blind curve and junction influence area to minimize unsafe U-turn and crossing movements.

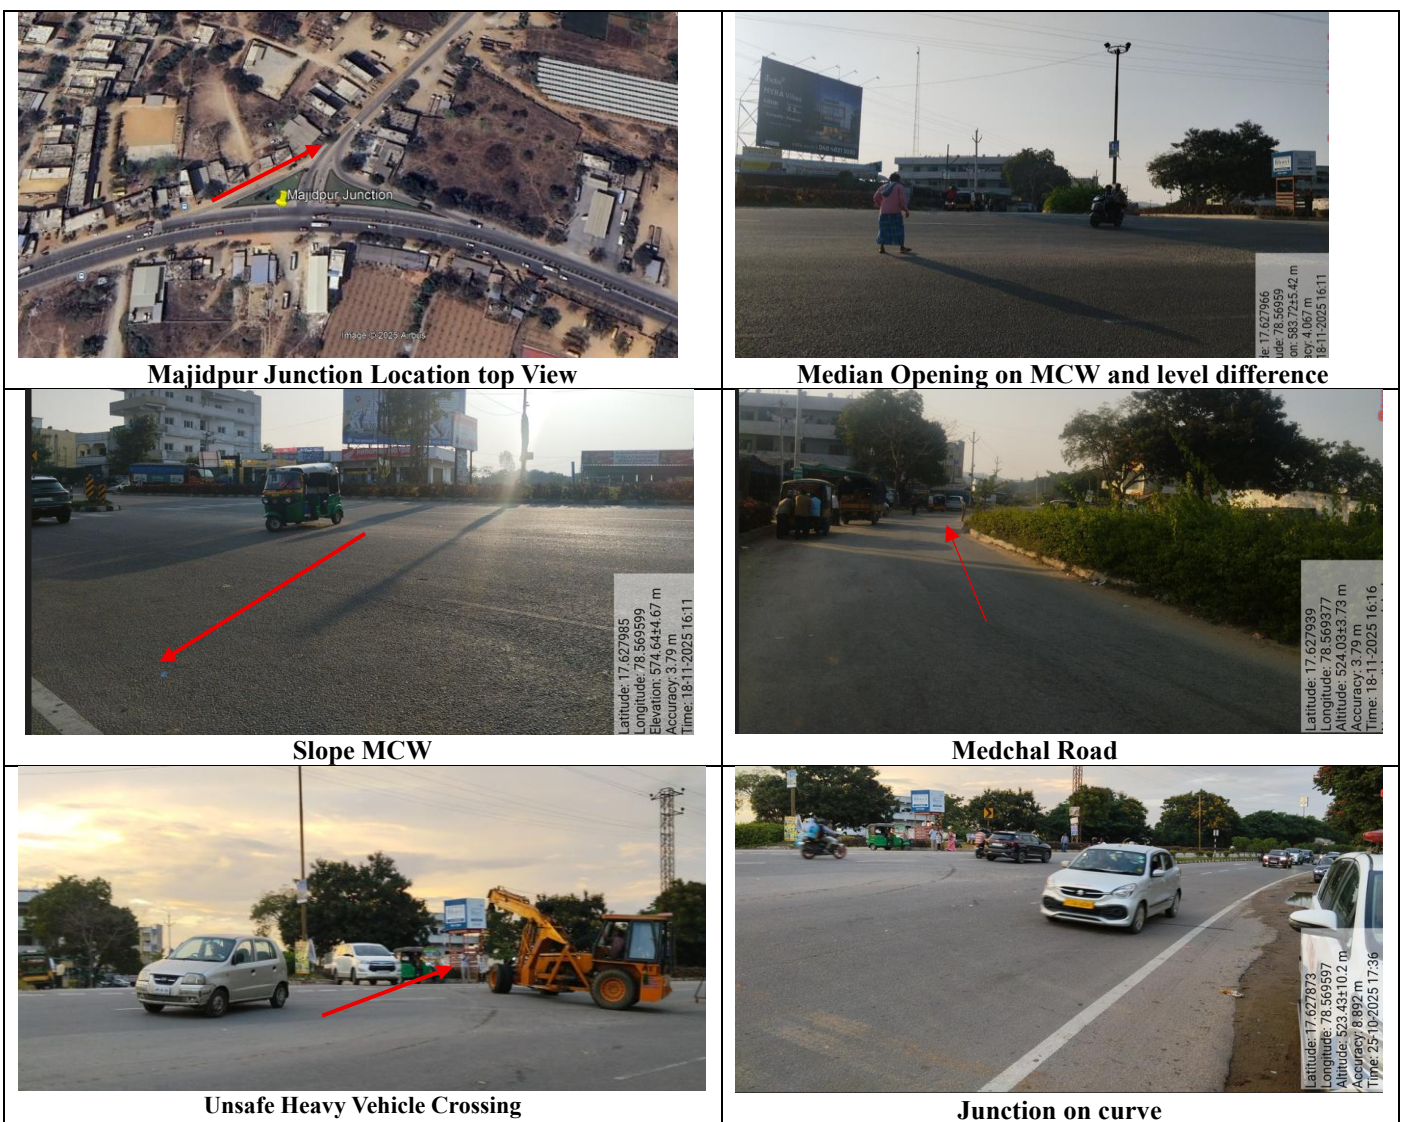
Existing photographs at this location

At present, **Majidpur Junction** is located on a **horizontal curve of the main carriageway (MCW)**, where **Medchal Road intersects the highway**. Due to the provision of **superelevation on the curved MCW**, the carriageway level is relatively higher than the intersecting Medchal Road, resulting in a noticeable **level difference at the junction**. A high volume of mixed traffic, including heavy and light vehicles during peak PCU conditions, enters the MCW from Medchal Road, with vehicles either merging towards **Karimnagar** or taking **U-turns at the median opening** to proceed towards **Hyderabad**. Simultaneously, vehicles from the MCW (Karimnagar direction) frequently cross the carriageway to access Medchal Road. Because of the level difference between the main carriageway and the intersecting road, heavy vehicles face difficulty while crossing the junction, resulting in slow movement and, at times, unexpected stopping or **rolling back** during crossing. These unsafe operating conditions, combined with curved alignment and high traffic interaction, have resulted in frequent **rear-end and side-swipe collisions** at the junction. Due to these geometric deficiencies and conflicting traffic movements, the Majidpur Junction has emerged as an **accident-prone location** requiring immediate safety and geometric improvement measures.

1. Pavement markings at the junction are severely worn out, resulting in poor visibility and reduced guidance to road users, especially during night-time and adverse weather conditions.

2. A number of road studs are damaged or missing and are therefore not effectively delineating the carriageway or traffic paths.
3. The existing transverse bar markings (TBMs) are faded and have lost their intended speed-calming and warning effectiveness.

4. Only one small high-mast light is provided at the junction, which is inadequate to ensure proper illumination of the intersection area during night hours.

5. Solar blinkers installed on the BHS along the main carriageway are provided and are presently functional.
6. Essential junction improvement signboards such as **STOP**, **speed limit**, and **junction ahead warning signs** are not provided on the Medchal Road, leading to inadequate advance warning for approaching traffic.

7. Pedestrian crossing facilities are provided on only one side of the junction, which is insufficient to ensure safe pedestrian movement across all approaches.

1. Provide three sets of **Transverse Bar Markings (TBM)** of 5 mm thickness on both approaches to the median opening at distances of 50 m, 80 m, and 120 m, along with road studs, to achieve effective speed reduction.

2. Install “**Accident-Prone Area**” warning signboards on both sides of the main carriageway and the intersecting road to alert drivers and improve safety awareness.

3. Provide **pavement markings** such as pedestrian crossing markings, edge lines, and centre lines as per IRC:35-2015, supplemented with road studs for improved delineation.

4. Provide hazard pavement markings at the Junction location as per IRC:35-2015 to warn drivers about the accident-prone zone.
5. Provide one sets of **Transverse Bar Markings (TBM)** of 5 mm thickness on the intersecting road at distances of 80m in advance of the merging point with the main carriageway, along with road studs, to control approach speeds.

6. Provide appropriate junction control and warning signboards on Medchal Intersection Road, such as **STOP**, **speed limit**, and **junction ahead** signs, as per IRC:67-2022, to regulate vehicle movements, improve driver awareness, and enhance overall junction safety.

7. Provide green-coloured road studs at the crossable lane markings at the Medchal Road and main carriageway merging location to improve delineation and driver guidance.

8. Provide highway lighting for a length of 250 m on both sides of the median opening, i.e., towards Hyderabad and towards Karimnagar, to improve visibility and safety.

9. Provide high Intensity High mast light junction location to enhance the highway lighting and clear visibility.

1. Reconstruct and level the junction area by reducing the level difference between MCW and Medchal Road to facilitate safe heavy vehicle crossing.
2. **Option-1:** Convert this junction into a **signalised intersection** to regulate traffic movements and improve safety.
3. **Option-2:** Reconstruct and upgrade this junction into a **grade-separated intersection** to eliminate traffic conflicts and improve overall safety and traffic flow.

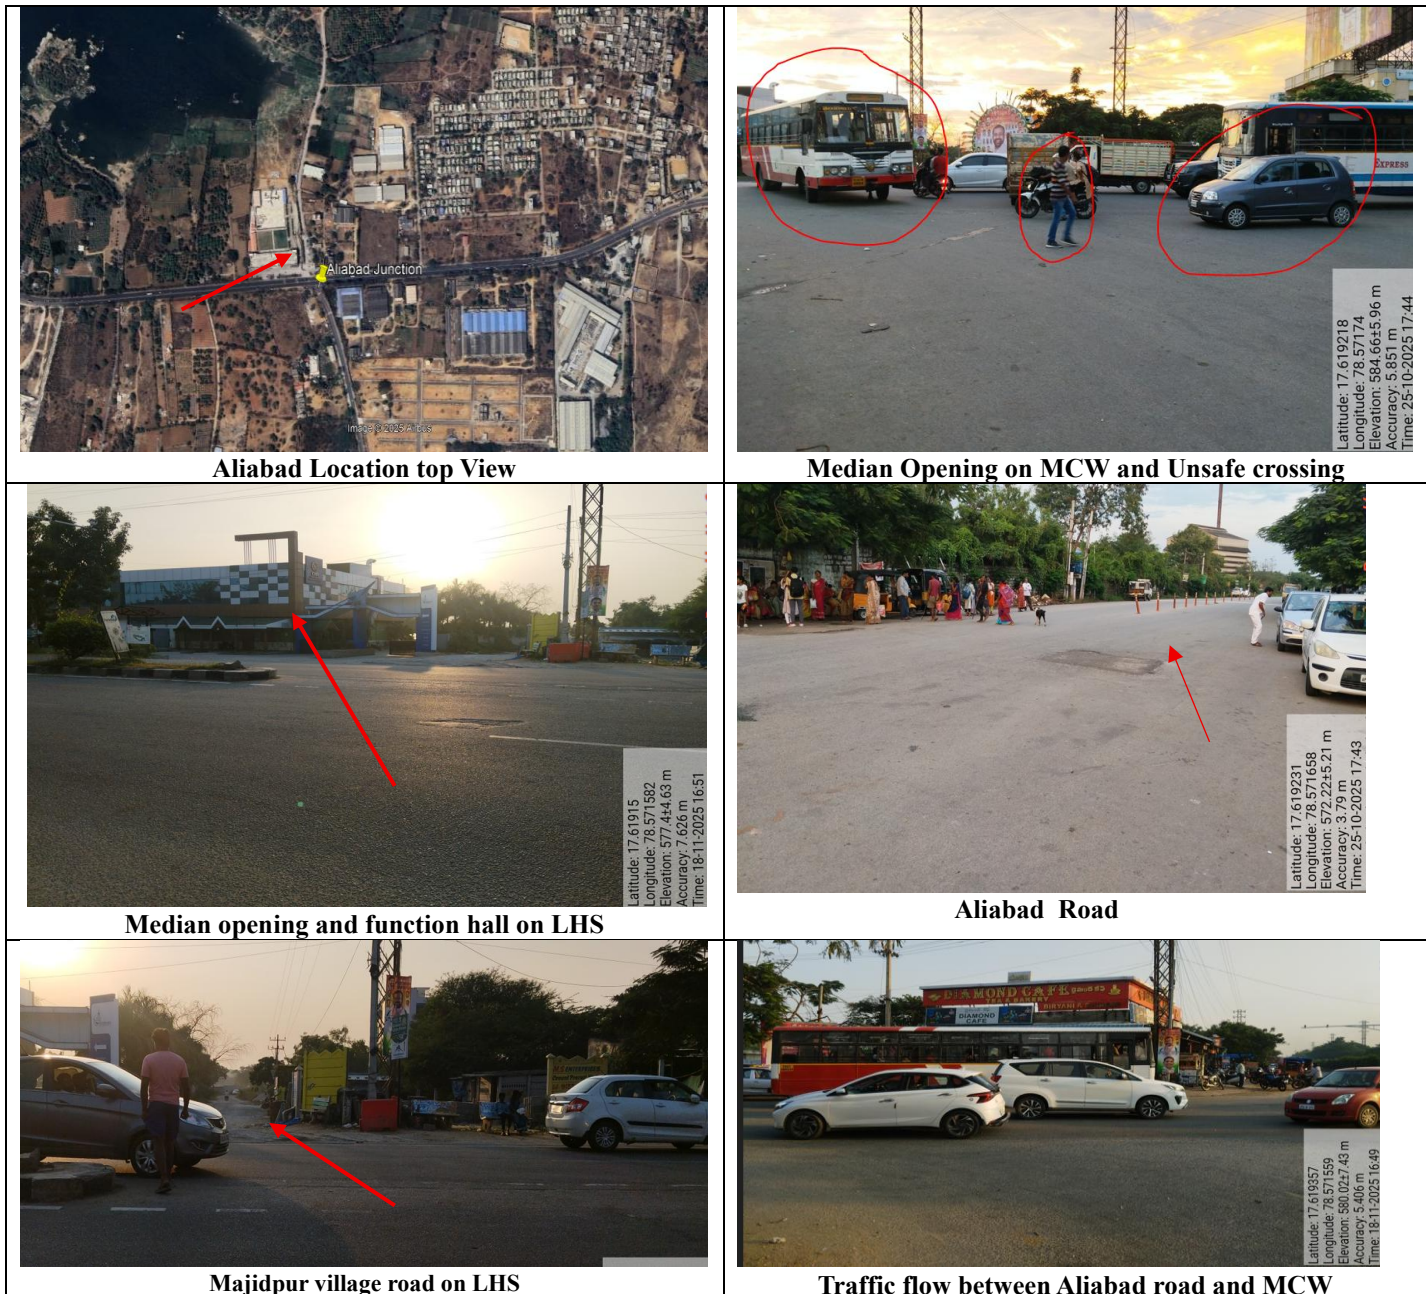
Existing photographs at this location

At present, the Aliabad Junction comprises the **Aliabad Village Road** intersecting the right-hand side of the main carriageway (MCW) along with an existing median opening. On the left-hand side, a minor Majidpur Village Road intersects the MCW very close to the Aliabad Village Road, and a function hall is located immediately adjacent to this junction area. The close spacing of two intersecting roads, presence of the median opening, and roadside activity generated by the function hall result in high vehicular and pedestrian interaction within a short influence length. These conditions create multiple conflict points, frequent turning and crossing movements, and driver confusion, thereby increasing the risk of **rear-end and side-swipe collisions**. Due to these combined factors, the Aliabad Junction has emerged as an accident-prone location requiring immediate safety improvements.

1. Pavement markings at the junction are severely worn out, resulting in poor visibility and reduced guidance to road users, especially during night-time and adverse weather conditions.
2. A number of road studs are damaged or missing and are therefore not effectively delineating the carriageway or traffic paths.

3. The existing transverse bar markings (TBMs) are faded and have lost their intended speed-calming and warning effectiveness.
4. Solar blinkers installed on the BHS along the main carriageway are provided and are presently functional.
5. Essential junction improvement signboards such as STOP, speed limit, and junction ahead warning signs are not provided on Aliabad Road, leading to inadequate advance warning for approaching traffic.
6. Pedestrian crossing facilities are not observed on MCW as well as Aliabad intersection road.
7. Adequate highway lighting is not provided along the main carriageway within the junction influence area, adversely affecting night-time visibility and safety.

1. Provide three sets of **Transverse Bar Markings (TBM)** of 5 mm thickness on both approaches to the median opening at distances of 50 m, 80 m, and 120 m, along with road studs, to achieve effective speed reduction.

2. Install “**Accident-Prone Area**” warning signboards on both sides of the main carriageway and the intersecting road to alert drivers and improve safety awareness.

3. Provide **pavement markings** such as pedestrian crossing markings, edge lines, and centre lines as per IRC:35-2015, supplemented with road studs for improved delineation.

4. Provide hazard pavement markings at the Junction location as per IRC:35-2015 to warn drivers about the accident-prone zone.
5. Provide one sets of **Transverse Bar Markings (TBM)** of 5 mm thickness on the intersecting road (Aliabad) at distances of 80m in advance of the merging point with the main carriageway, along with road studs, to control approach speeds.

6. Provide appropriate junction control and warning signboards on Aliabad Intersection Road, such as **STOP, speed limit, and junction ahead** signs, as per IRC:67-2022, to regulate vehicle movements, improve driver awareness, and enhance overall junction safety.

7. Provide crossable lane marking along with green colour road studs at the Aliabad Road and main carriageway merging location to improve delineation and driver guidance.

8. Provide highway lighting for a length of 250 m on both sides of the median opening, i.e., towards Hyderabad and towards Karimnagar, to improve visibility and safety.

9. Provide high Intensity High mast light junction location to enhance the highway lighting and clear visibility.

1. **Option-1:** Convert this junction into a **signalised intersection** to regulate traffic movements and improve safety.
2. **Option-2:** Reconstruct and upgrade this junction into a **grade-separated intersection** to eliminate traffic conflicts and improve overall safety and traffic flow.

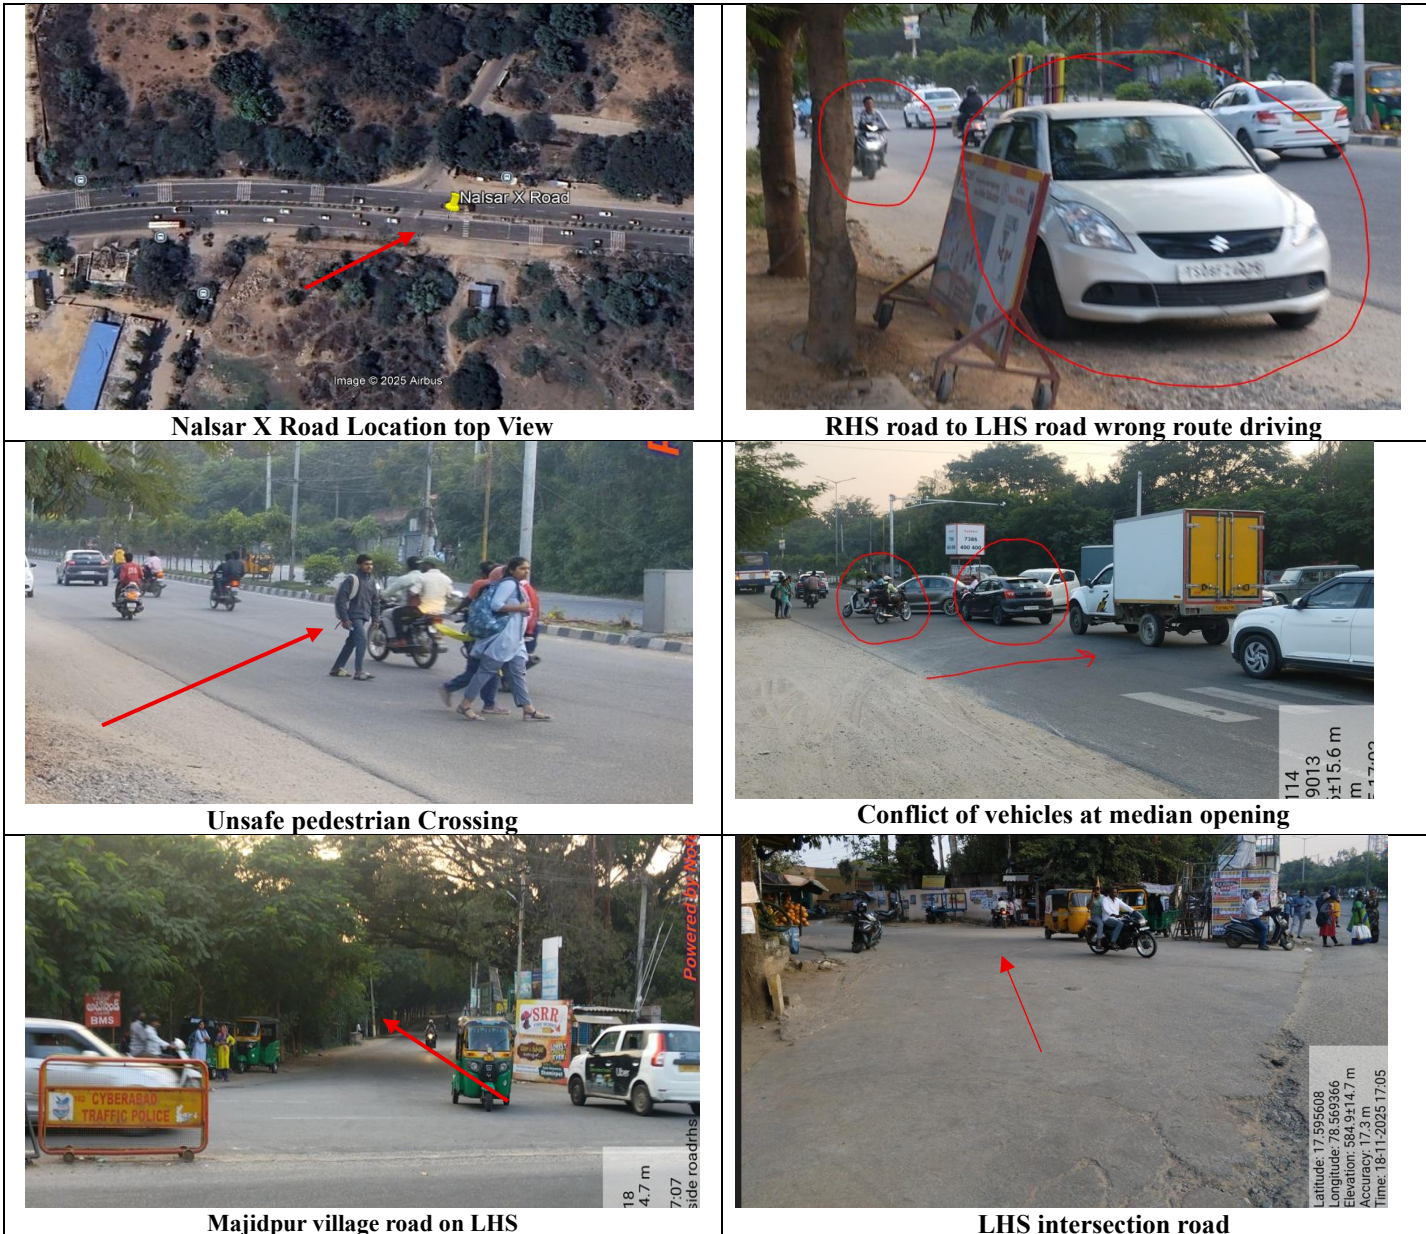
Existing photographs at this location

At present, one intersecting road is located on the left-hand side (LHS) of the main carriageway along with an existing median opening. Another intersecting road is situated approximately 170 m from the median opening on the right-hand side (RHS) in the Hyderabad direction. Due to the close spacing of these access points, vehicles frequently attempt to access the LHS intersecting road from the RHS intersecting road by adopting **wrong-side driving** towards the median opening and making U-turn movements. In addition, pedestrians are observed crossing the main carriageway at this location without **designated crossing facilities**, further increasing traffic conflicts. These unsafe and uncontrolled vehicle and pedestrian movements create severe conflicts with through traffic on the main carriageway, resulting in frequent **rear-end and side-swipe collisions**. Because several access points are located very close to each other and vehicles frequently move in the wrong direction, this location has become an accident-prone area and needs immediate safety and access control measures.

1. Pavement markings at the junction are severely worn out, resulting in poor visibility and reduced guidance to road users, especially during night-time and adverse weather conditions.
2. At present there is No studs are observed.

3. The existing transverse bar markings (TBMs) are faded and have lost their intended speed-calming and warning effectiveness.
4. Solar blinkers installed on the BHS along the main carriageway are provided and are presently functional.
5. Essential junction improvement signboards such as STOP, speed limit, and junction ahead warning signs are not provided on RHS and LHS intersection roads, leading to inadequate advance warning for approaching traffic.
6. Pedestrian crossing facilities are not observed on MCW as well as intersection roads.
7. Highway lighting has been provided along the main carriageway.

1. Provide three sets of **Transverse Bar Markings (TBM)** of 5 mm thickness on both approaches to the median opening at distances of 50 m, 80 m, and 120 m, along with road studs, to achieve effective speed reduction.

2. Install “**Accident-Prone Area**” warning signboards on both sides of the main carriageway and the intersecting road to alert drivers and improve safety awareness.

3. Provide **pavement markings** such as pedestrian crossing markings, edge lines, and centre lines as per IRC:35-2015, supplemented with road studs for improved delineation.

4. Provide hazard pavement markings at the Junction location as per IRC:35-2015 to warn drivers about the accident-prone zone.
5. Provide one sets of **Transverse Bar Markings (TBM)** of 5 mm thickness on the intersecting roads at distances of 80m in advance of the merging point with the main carriageway, along with road studs, to control approach speeds.

6. Provide appropriate junction control and warning signboards on Intersection Roads, such as **STOP**, **speed limit**, and **junction ahead** signs, as per IRC:67-2022, to regulate vehicle movements, improve driver awareness, and enhance overall junction safety.

7. Provide crossable lane marking along with green colour road studs at intersection roads and main carriageway merging location to improve delineation and driver guidance.

8. Provide high Intensity High mast light junction location to enhance the highway lighting and clear visibility.
9. Regulate wrong-side traffic through strict enforcement measures, including routine Traffic fines and monitoring.

10. Provide pedestrian signal facilities at the junction to regulate pedestrian movements, improve crossing safety, and minimize conflicts with vehicular traffic.

11. Provide highway lighting on the LHS intersecting road to improve night-time visibility and enhance overall safety.

1. **Option-1:** Convert this junction into a **signalised intersection** to regulate traffic movements and improve safety.
2. **Option-2:** Reconstruct and upgrade this junction into a **grade-separated intersection** to eliminate traffic conflicts and improve overall safety and traffic flow.

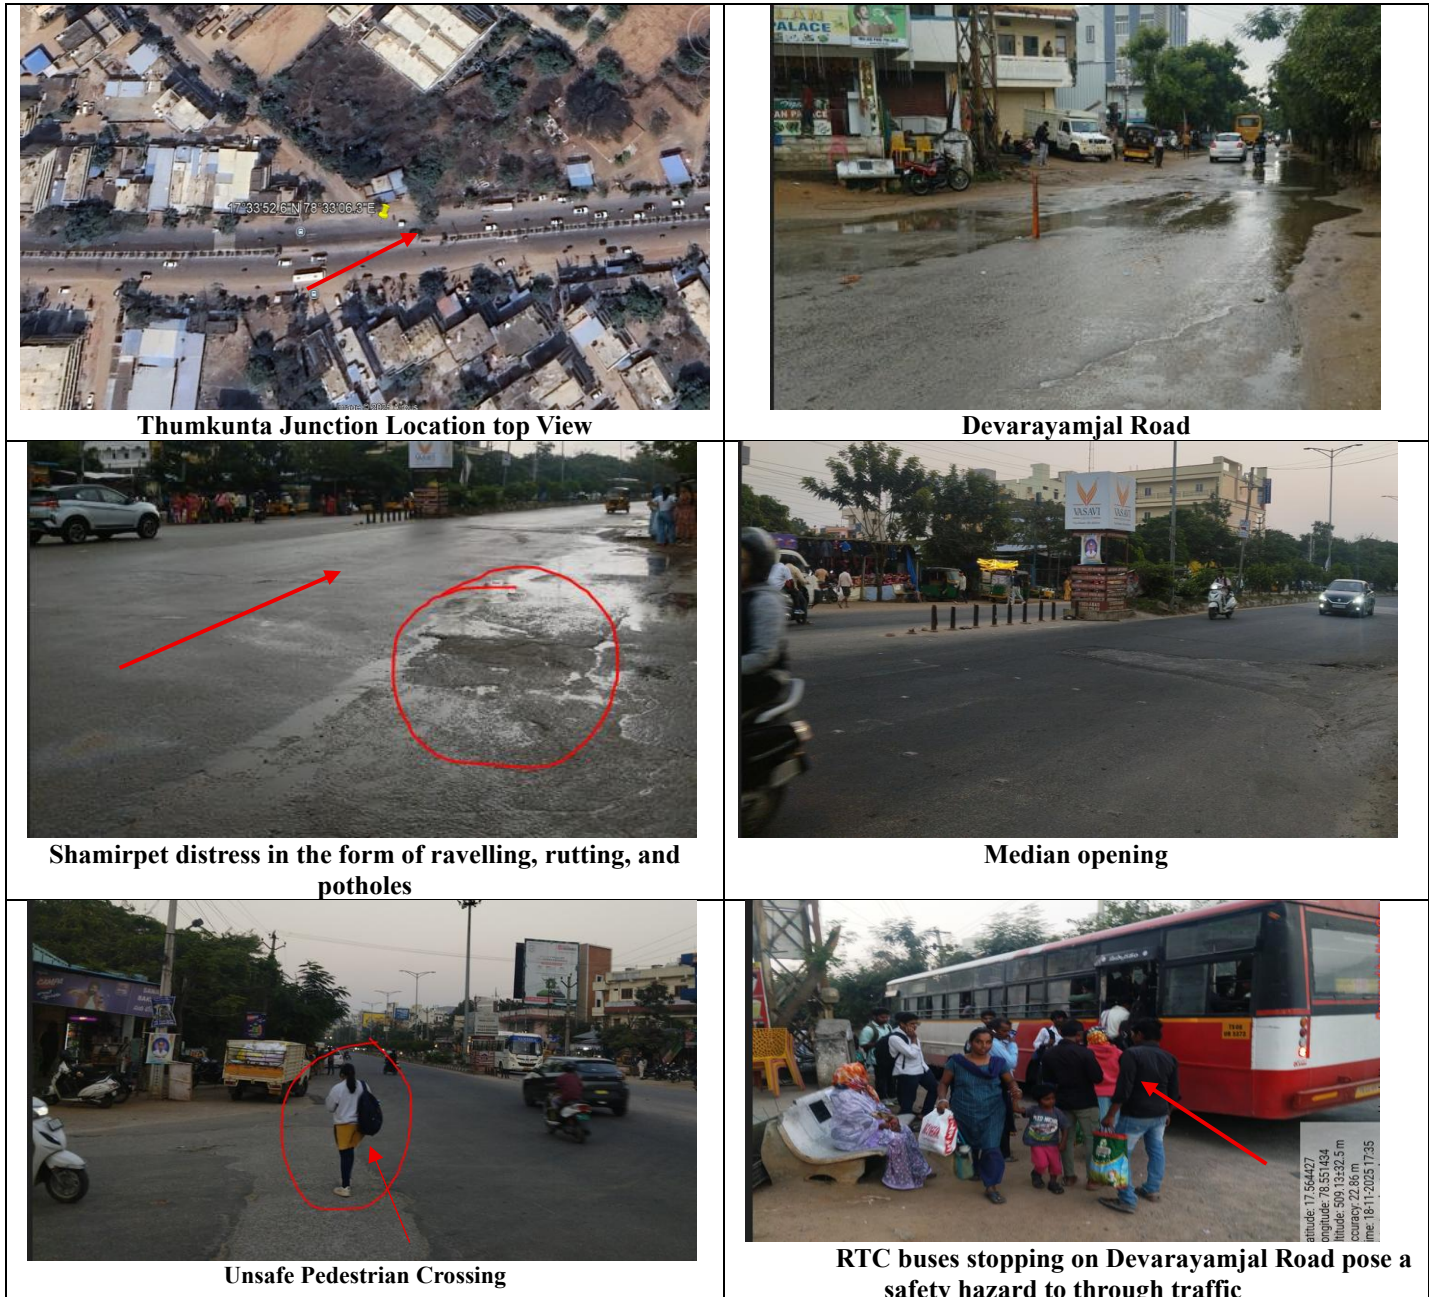
Existing photographs at this location

At present, Devarayamjal Road intersects the main carriageway (MCW) at the **Tumakunta Junction**, where an existing median opening is also provided within the junction influence area. The presence of this median opening, combined with frequent turning, crossing, and U-turn movements from **Devarayamjal Road**, results in multiple vehicular conflict points with through traffic on the MCW. These uncontrolled movements lead to speed differentials, sudden braking, and lane changes on the main carriageway, increasing the risk of **rear-end and side-swipe collisions**. Due to the intersection layout and the median opening within a short influence length, the Tumakunta Junction has emerged as an accident-prone location, needs immediate safety and access control measures.

1. Pavement markings at the junction are severely worn out, resulting in poor visibility and reduced guidance to road users, especially during night-time and adverse weather conditions.
2. At present there is No studs are observed.

3. The existing transverse bar markings (TBMs) are faded and have lost their intended speed-calming and warning effectiveness.
4. Essential junction improvement signboards such as STOP, speed limit, and junction ahead warning signs are not provided on intersection roads, leading to inadequate advance warning for approaching traffic.
5. Pedestrian crossing facilities are not observed on MCW as well as intersection roads.
6. Highway lighting has been provided along the main carriageway.
7. Shamirpet Road (MCW) and Devarayamjal Road are exhibiting significant pavement surface distress in the form of ravelling, rutting, and potholes, with waterlogging observed at several locations, adversely affecting riding quality and road safety.

1. Provide three sets of **Transverse Bar Markings** (TBM) of 5 mm thickness on both approaches to the median opening at distances of 50 m, 80 m, and 120 m, along with road studs, to achieve effective speed reduction.

2. Install “**Accident-Prone Area**” warning signboards on both sides of the main carriageway and the intersecting road to alert drivers and improve safety awareness.

3. Carry out immediate pavement repairs on Shamirpet Road (MCW) and Devarayamjal Road to rectify ravelling, rutting, potholes, and waterlogging, and improve overall road safety.

4. Provide **pavement markings** such as pedestrian crossing markings, edge lines, and centre lines as per IRC:35-2015, supplemented with road studs for improved delineation.

5. Provide hazard pavement markings at the Junction location as per IRC:35-2015 to warn drivers about the accident-prone zone.
6. Provide one sets of **Transverse Bar Markings (TBM)** of 5 mm thickness on the intersecting roads at distances of 80m in advance of the merging point with the main carriageway, along with road studs, to control approach speeds.

7. Provide appropriate junction control and warning signboards on Intersection Roads, such as **STOP, speed limit, and junction ahead** signs, as per IRC:67-2022, to regulate vehicle movements, improve driver awareness, and enhance overall junction safety.

8. Provide crossable lane marking along with green colour road studs at intersection roads and main carriageway merging location to improve delineation and driver guidance.

9. Provide high Intensity High mast light junction location to enhance the highway lighting and clear visibility.
10. Since an existing median opening is located at approximately 60 m, a **storage lane shall be provided on the main carriageway as per IRC: SP:41-1994** to facilitate safe U-turn movements of BHS vehicles.

1. **Option-1:** Convert this junction into a **signalised intersection** to regulate traffic movements and improve safety.
2. **Option-2:** Reconstruct and upgrade this junction into a **grade-separated intersection** to eliminate traffic conflicts and improve overall safety and traffic flow.
