### Location-1 current scenario at Existing Traffic at Metro Pillar No. 1387 (Begumpet – Rasoolpura Corridor):

### Location -2: current scenario at pillar No. 1357 Near Prakash Nagar metro station

**Location:3: current scenario at pillar No. 1315 Near Begumpet Police station Road**

### Location 4: current scenario at pillar No. 1303 Near Rasoolpura metro station Road

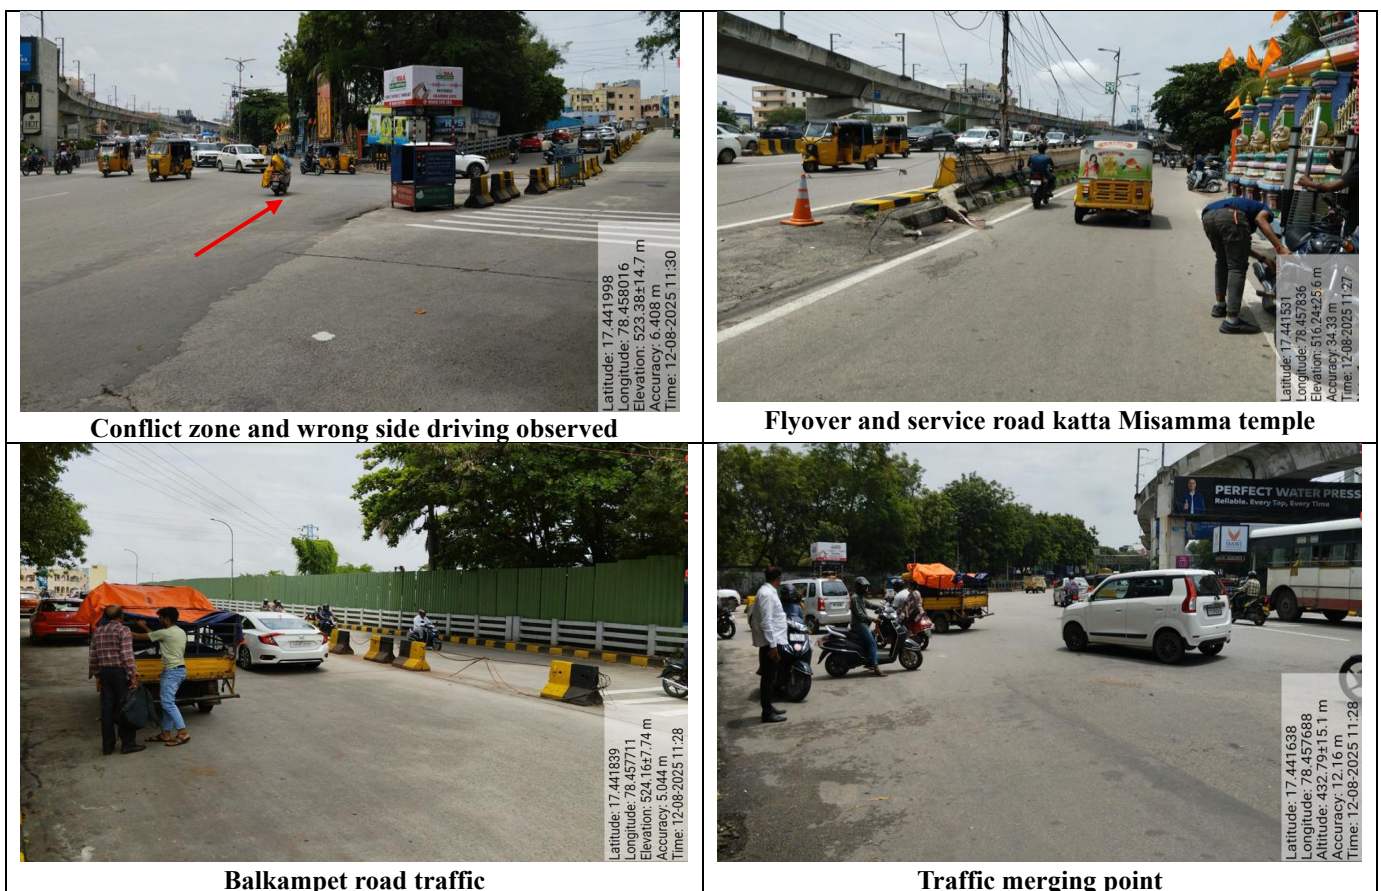
#### Existing photographs at this location

At present, vehicular traffic originating from Begumpet Metro Station is approaching towards Rasoolpura through both the flyover and the service road. At Metro Pillar No. 1387, this traffic stream is further compounded by vehicles merging from Balkampet Road, thereby creating a multi-directional conflict zone. The Katta Misamma Temple is located beside the service road, and many pedestrians cross the road here to reach the temple. This causes frequent pedestrian–vehicle conflicts. In addition, some vehicles are seen using the wrong side from Rasoolpura to access the temple, leading to contraflow traffic and further confusion. Because of these conditions—multiple traffic streams merging, no proper channelisation, frequent pedestrian crossings, and wrong-side driving—this location has become a high-conflict area with a high risk of accidents. This location can be classified as an **accident-prone zone**.

1. **Balkampet Road:** Gaps in the concrete crash barriers are allowing vehicles to suddenly move from the left side to the right side and vice versa, creating unsafe conditions.
2. **Katta Misamma Temple Location:** The curve near the temple reduces visibility, resulting in inadequate stopping sight distance for drivers.
3. **Speed Management:** No speed regulation or traffic calming measures are provided on the flyover or service road, leading to uncontrolled vehicle speeds.
4. **Warning Signage:** No “Accident-Prone Area” signboards are placed on Begumpet Road and Balkampet Road to warn drivers in advance.

1. Provide chevron sign boards along the entire curve section of the service road as per IRC:67-2022.
2. Provide three sets of transverse bar markings (5 mm thickness) on the flyover, placed at 50 m, 80 m, and 120 m in advance of the service road–flyover merging location.

3. Provide one set of transverse bar markings (5 mm thickness) on the service road, 50 m in advance of the temple location.
4. Provide continuous RCC crash barriers without gaps on Balkampet Road and fix retro-reflective median markers for better night visibility.

5. Provide three sets of transverse bar markings (5 mm thickness) on Balkampet Road, placed at 50 m, 80 m, and 120 m in advance of the hazard location.

6. Extend the crash barriers on Balkampet Road towards Rasoolpura to facilitate safe turning manoeuvres.
7. Provide hazard pavement markings at the merging location to alert drivers about the accident-prone area as per IRC:35-2015.

8. Install “Accident-Prone Area” signboards on the flyover, service road, and Balkampet Road approaches.
9. Regulate wrong-side traffic through strict enforcement measures, including routine Traffic fines and monitoring.

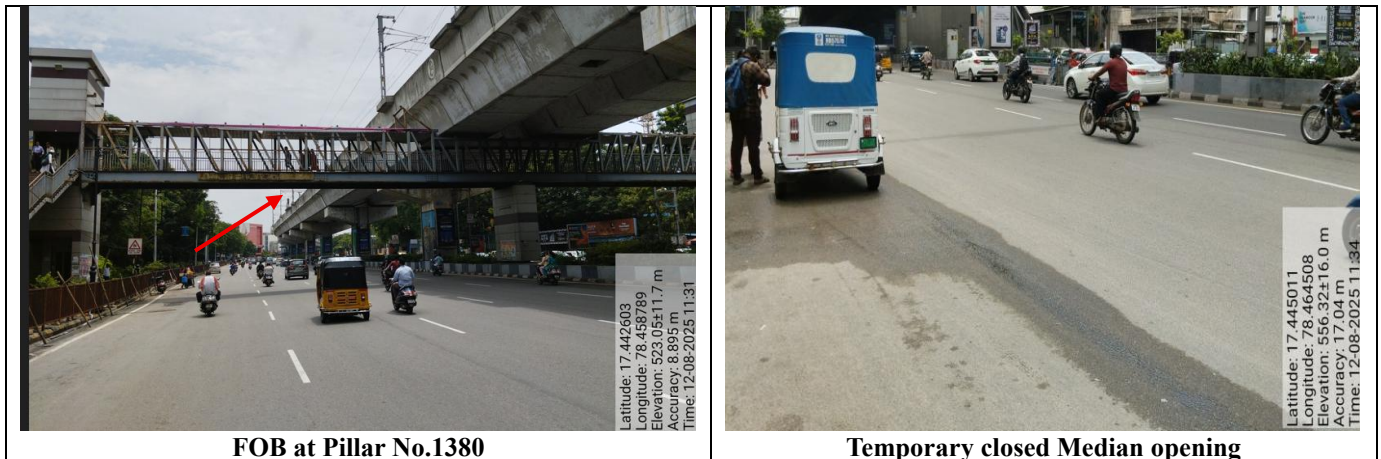
### Existing photographs at this location

At Pillar No. 1357, there is an existing median opening which is temporarily closed; however, pedestrians continue to cross at this point because there is no nearby Foot Over Bridge—the nearest FOB at Pillar No. 1380 is located at a considerable distance. As a result, pedestrians frequently cross the median at this location. These mid-block crossings create significant **pedestrian–vehicle conflict points**, particularly during peak traffic hours, as vehicles traveling from Begumpet to Prakash Nagar and vice versa are forced to slow down or stop, increasing the risk of **rear-end and side-swipe collisions**. The combination of high pedestrian activity, inadequate crossing infrastructure, and continuous traffic flow has rendered this location an **accident-prone area**.

1. The temporarily closed median opening is protected with traffic barricades; however, the barricades are of insufficient height, allowing pedestrians to easily cross them.
2. No traffic calming measures have been provided on either side of the roadway to reduce vehicle speeds.

1. The median opening should be **permanently closed** and provided with **continuous guardrails of 1.5 m height** to prevent pedestrians from crossing at this location.
2. Provide **one set of transverse bar markings (TBM) with 5 mm thickness** on both sides, 50m in advance of the median opening, to reduce vehicle speeds.
3. **“Accident-Prone Area” signboards** shall be installed on both sides to alert drivers and enhance safety awareness.

1. A **Foot Over Bridge (FOB)** shall be constructed to provide a safe pedestrian crossing facility at this location.

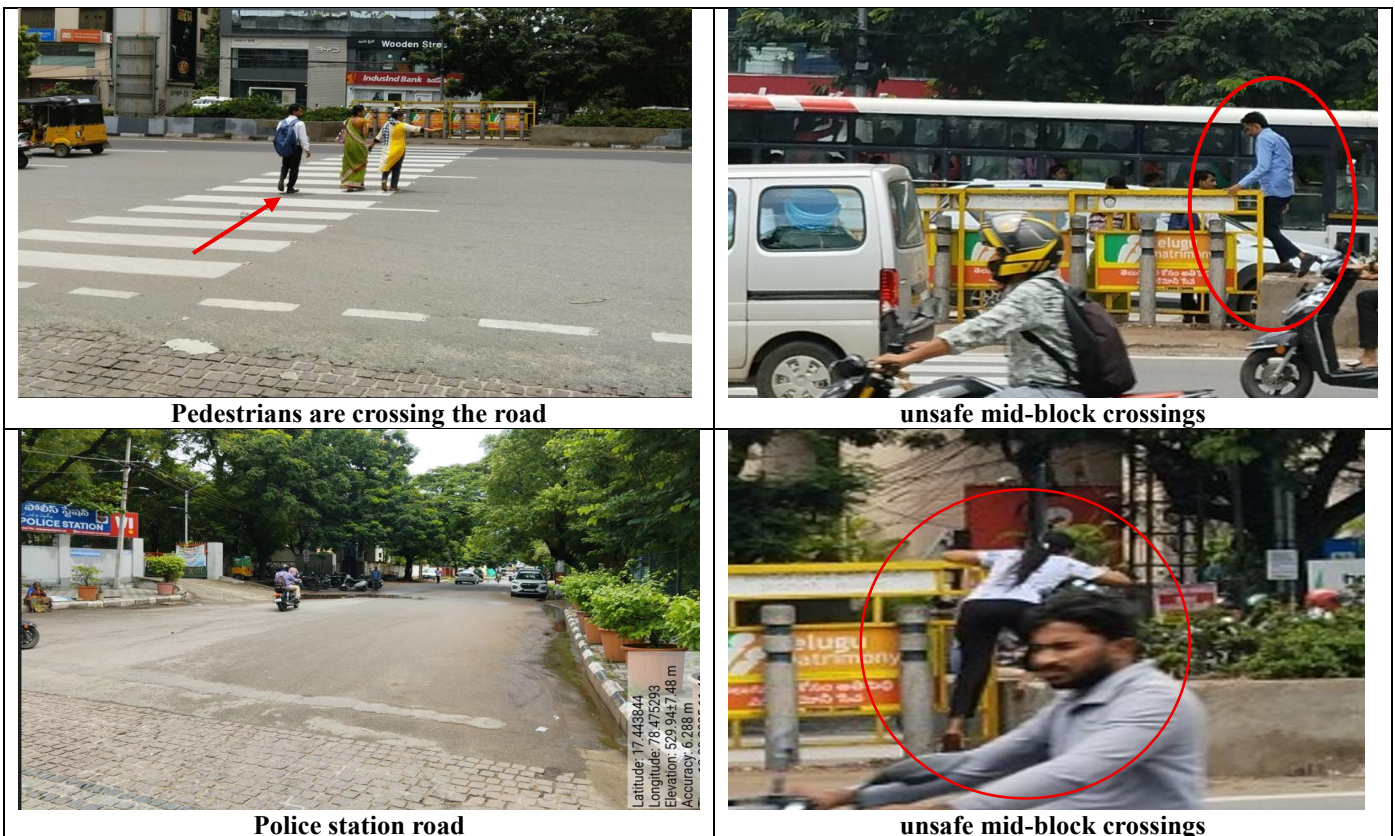
**Existing photographs at this location**

At Pillar No. 1315, there is an existing median opening which is temporarily closed; however, pedestrians continue to cross at this point due to the absence of a nearby Foot Over Bridge. Consequently, frequent mid-block pedestrian crossings are observed at this location. These crossings create significant **pedestrian–vehicle conflict points**, particularly during peak traffic hours, as vehicles traveling between Begumpet and Rasoolpura—and additionally traffic merging from Begumpet Police Station Cross Road—are forced to slow down or stop, increasing the risk of **rear-end and side-swipe collisions**. The combination of high pedestrian activity, lack of proper crossing facilities, and continuous traffic flow has made this location **accident-prone**.

1. The temporarily closed median opening is protected with traffic barricades; however, the barricades are of insufficient height, allowing pedestrians to easily cross them.
2. No traffic calming measures have been provided on either side of the roadway to reduce vehicle speeds.

1. The median opening should be **permanently closed** and provided with **continuous guardrails of 1.5 m height** to prevent pedestrians from crossing at this location.
2. Provide **one set of transverse bar markings (TBM) with 5 mm thickness** on both sides, 50m in advance of the median opening, to reduce vehicle speeds.
3. **Accident-Prone Area” signboards** shall be installed on both sides to alert drivers and enhance safety awareness.

1. A **Foot Over Bridge (FOB)** shall be constructed to provide a safe pedestrian crossing facility at this location.

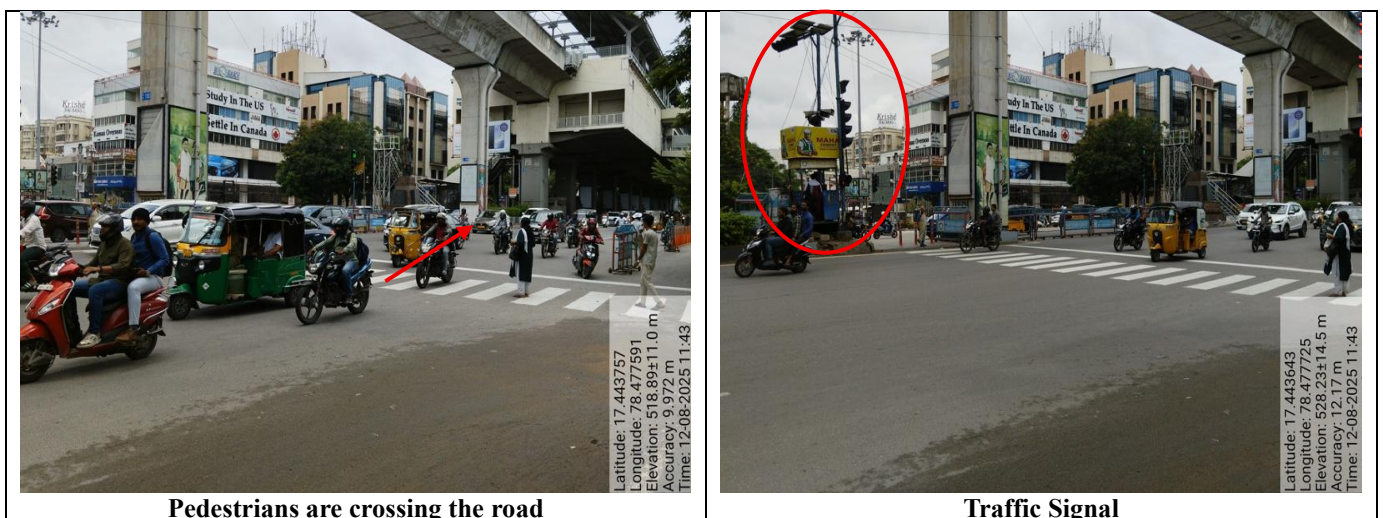
#### Existing photographs at this location

At Pillar No. 1303, there is an existing median opening where frequent mid-block pedestrian crossings are observed. These crossings create significant **pedestrian-vehicle conflict points**, particularly during peak traffic hours, as vehicles traveling between Begumpet and Rasoolpura are interrupted by pedestrian movement. Although a pedestrian signal is provided at this location, its timing is inadequate during peak periods, resulting in unsafe crossing conditions. In addition, during night hours, many vehicles fail to comply with the pedestrian signal due to the absence of effective speed calming measures. Owing to these factors, this location has developed into an **accident-prone area**.

1. Pedestrian signal provided is inadequate, as the signal timing does not match pedestrian demand in peak periods
2. Unsafe crossing conditions prevail due to short signal duration and high traffic flow.
3. During night hours, vehicles often ignore the pedestrian signal, leading to increased risk.
4. Lack of speed calming measures contributes to non-compliance by vehicles.

1. **Two sets of Transverse Bar Markings (TBM)** of 5 mm thickness shall be provided on both approaches, with the first set at 50 m and the second set at 80 m in advance of the median opening, to reduce vehicle speeds.
2. **“Accident-Prone Area” signboards** shall be installed on both approaches to caution drivers and improve safety awareness.
3. **Solar studs** shall be installed along the pedestrian crossing pavement marking to improve night-time visibility and enhance pedestrian safety.

1. A **Foot Over Bridge (FOB)** shall be constructed to provide a safe pedestrian crossing facility at this location.

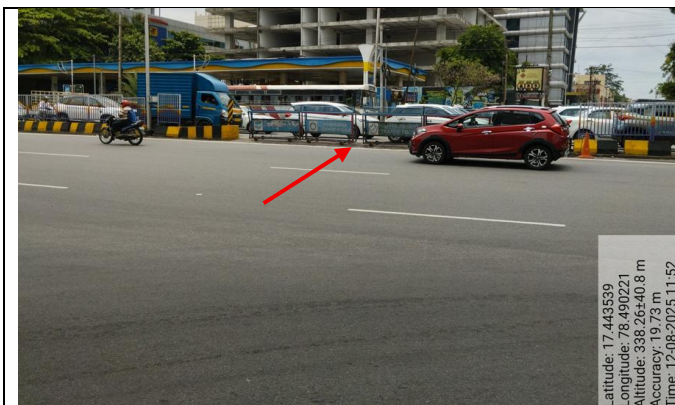
Currently, vehicular traffic originating from Begumpet towards Paradise Metro Station Road is carried through both the flyover and the service road. At Metro Pillar No. 1252, there exists a median opening that has been temporarily closed; however, in the absence of a nearby Foot Over Bridge, pedestrians continue to cross at this location. As a result, frequent pedestrian movements across the median are observed. These pedestrian crossings create critical pedestrian–vehicle conflict points, particularly during peak traffic hours, as vehicles moving between Begumpet and Paradise Metro Station Road—along with merging traffic from Bowenpally side road—are compelled to slow down or halt abruptly. This increases the probability of rear-end and side-swipe collisions. The prevailing conditions of high pedestrian activity, lack of formal crossing facilities, and continuous vehicular movement have together made this location a highly accident-prone zone.

Temporary closed median

1. The median opening should be permanently closed and provided with **continuous guardrails of 1.5 m height** to prevent pedestrians from crossing at this location.
2. Provide **one set of transverse bar markings (TBM) with 5 mm thickness** on both sides, 50m in advance of the median opening, to reduce vehicle speeds.
3. Accident-Prone Area” signboards shall be installed on both sides to alert drivers and enhance safety awareness.
4. From the Bowenpally side road, the crash barriers need some extension towards Paradise Road to allow safe turning for Bowenpally traffic

1. A **Foot Over Bridge (FOB)** shall be constructed to provide a safe pedestrian crossing facility at this location.

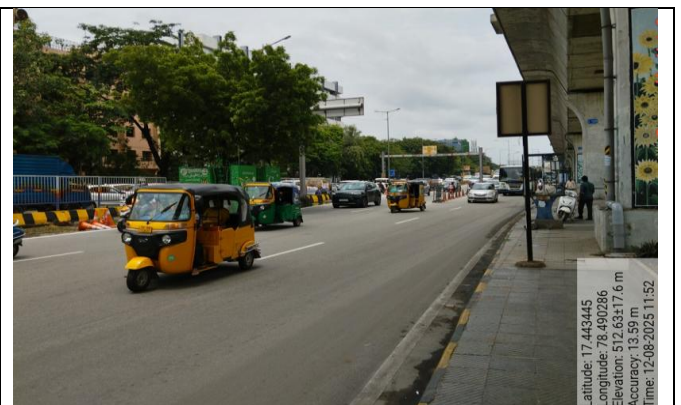
Begumpet road traffic

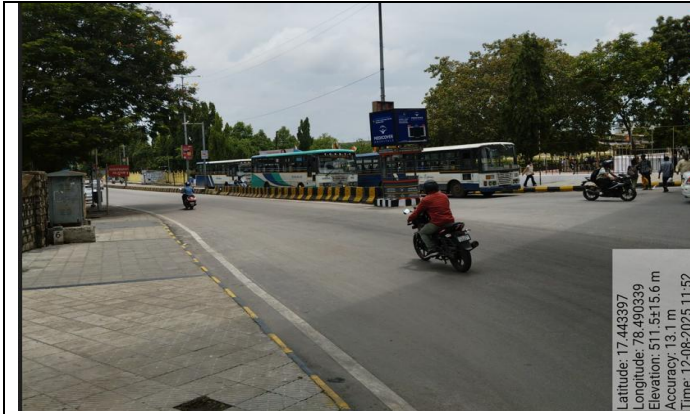
**Bowenpally Road**

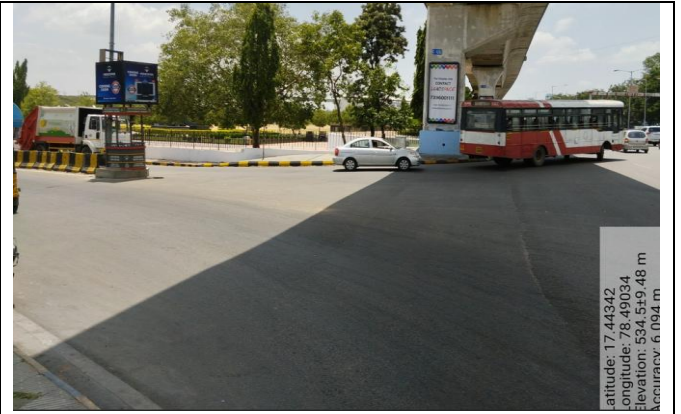
**Bowenpally vehicles merging with Paradise Road vehicles**

1. **No Foot Over Bridge or formal pedestrian crossing** facility is available nearby.
2. Vehicles coming from Bowenpally side merge with the traffic flow from Begumpet towards Paradise Metro Station Road, creating conflict points with through traffic.
3. No traffic calming measures have been provided on either side of the roadway to reduce vehicle speeds.
